Caltrans Division of Research, Innovation and System Information

FEBRUARY 2015

Repair of Earthquake-Damaged Columns with Fractured Bars

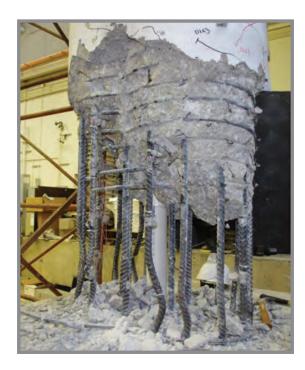
R-Calt-1 after concrete repair

The two columns repaired with mechanical bar couplers in the plastic hinge region did not sustain damage during the test, indicating that this method restores the column's strength and deformation capacity. Both types of couplers were effective. The column that was repaired with externally bonded prefabricated CFRP strips and jacket was also able to restore the column strength and deformation capacity without requiring replacement of the internal reinforcement.
